NASA CR-120980  
BAC Report No. 8654-953003

# FINAL REPORT APPENDIX

## NONDESTRUCTIVE TESTS OF REGENERATIVE CHAMBERS

**FINAL REPORT - APPENDIX**  
**NONDESTRUCTIVE TESTS OF REGENERATIVE CHAMBERS**

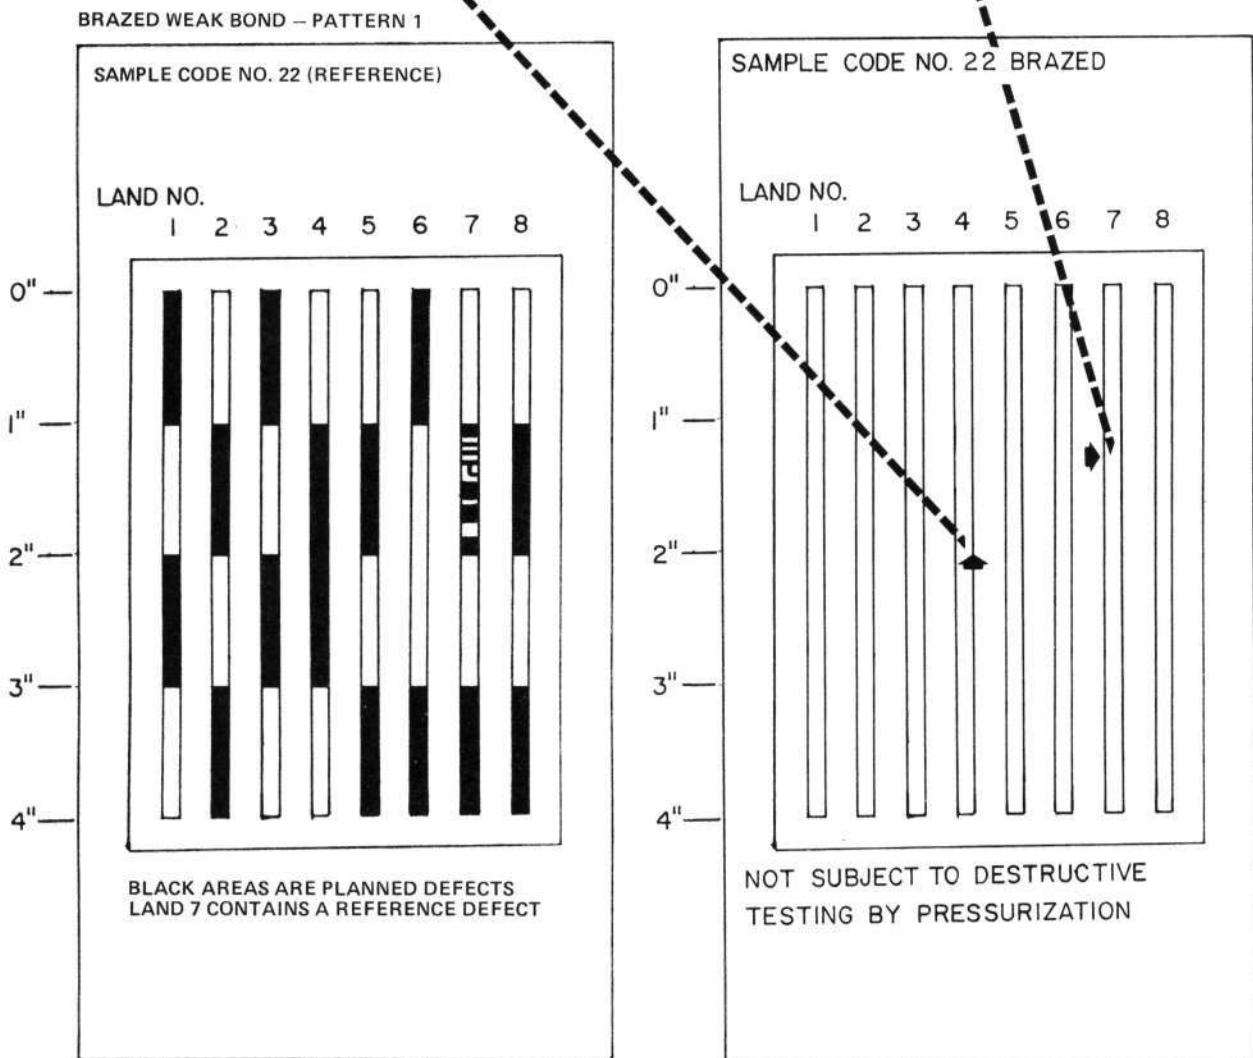
FIGURE A-21

TEST RESULTS ON BRAZED WEAK BOND PANEL NO. 22

TEST PRESSURE 1440 PSI

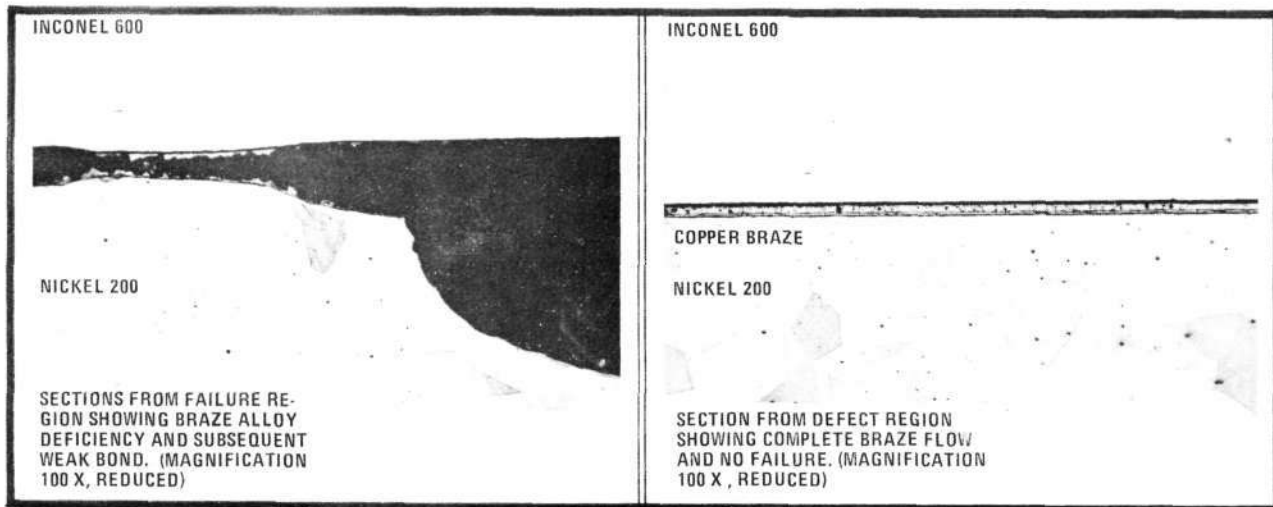
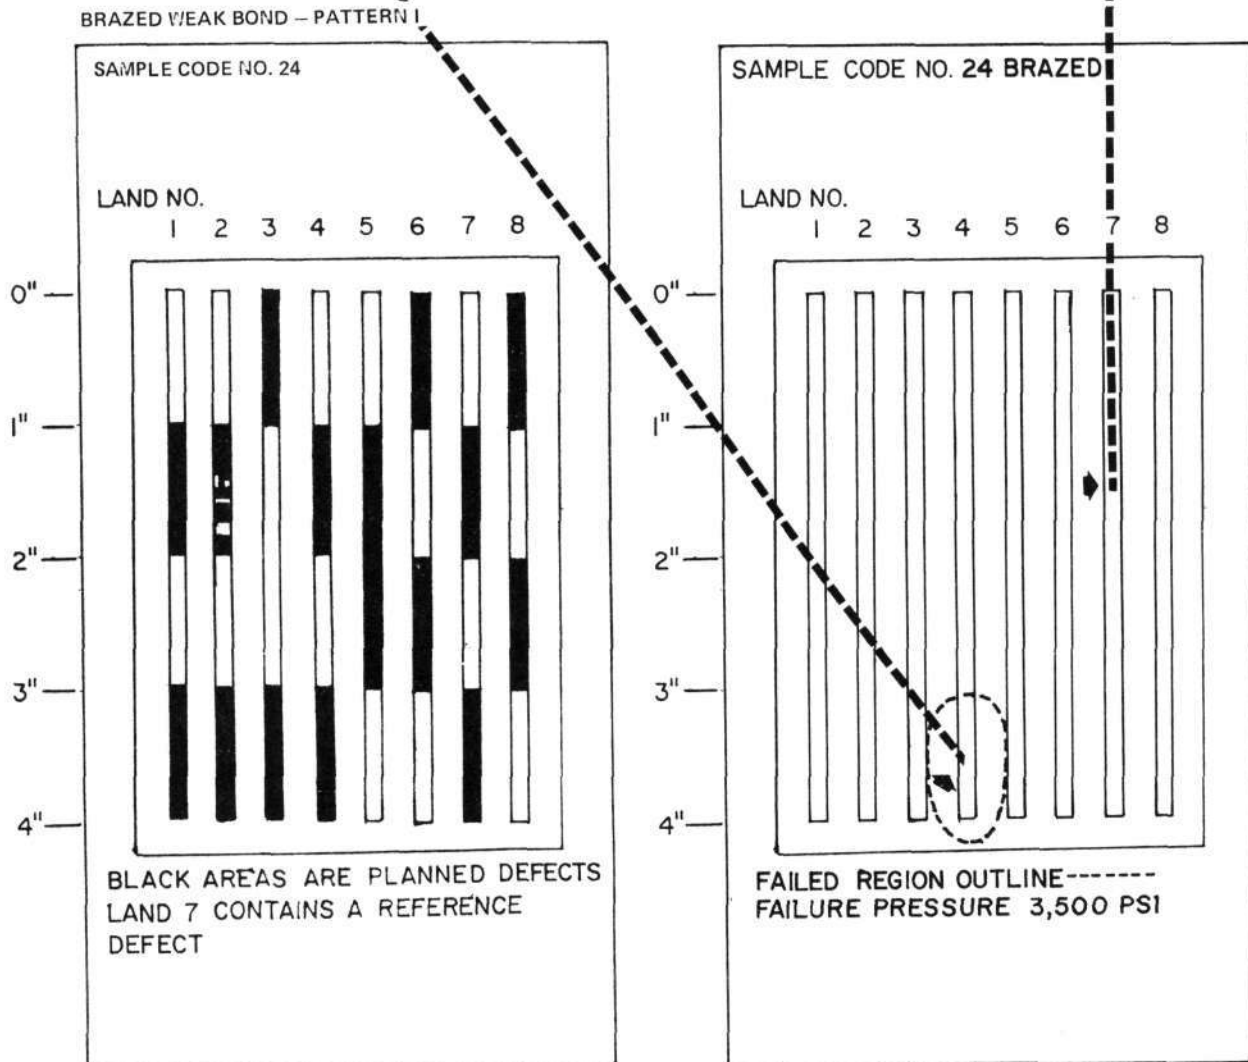
FIGURE A-22

TEST RESULTS FOR BRAZED WEAK BOND PANEL NO. 24

TEST PRESSURE 200 PSI

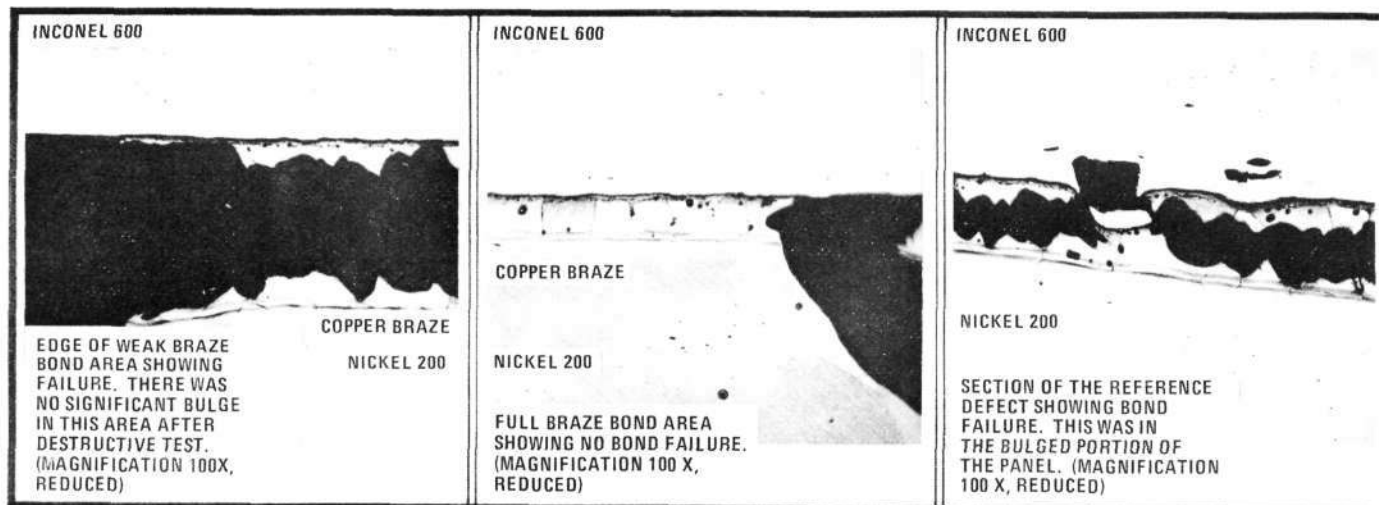
FIGURE A-24

# BRAZED WEAK BOND - PATTERN 2

TEST RESULTS ON BRAZED WEAK BOND PANEL NO. 28

TEST PRESSURE 100 PSI

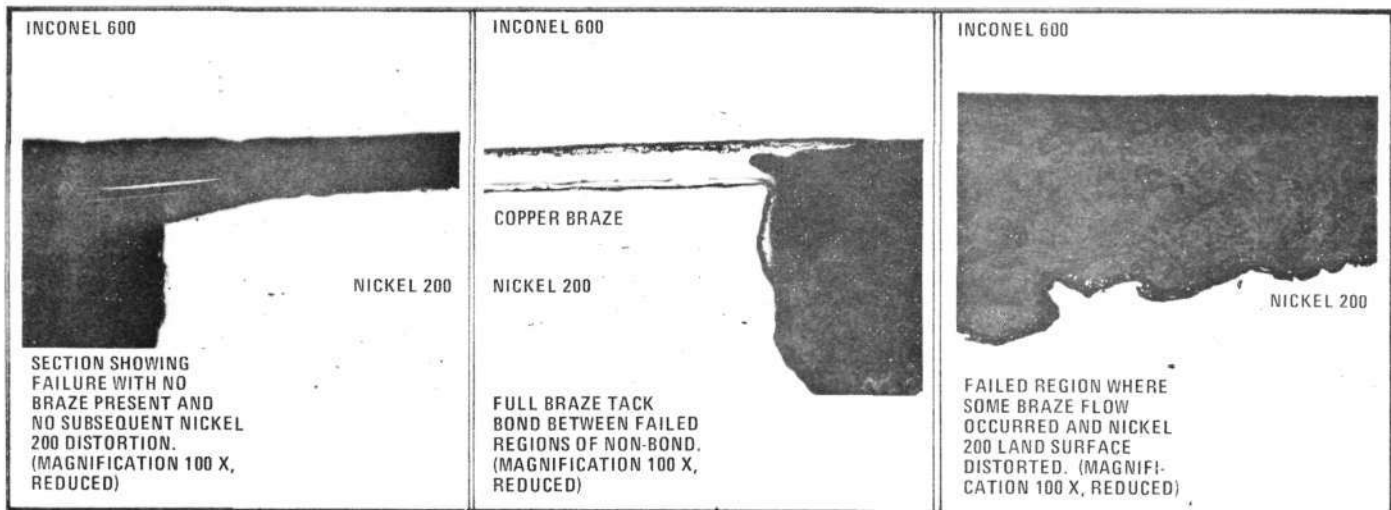
FIGURE A-25

BRAZED WEAK BOND - PATTERN 3

TEST RESULTS ON BRAZED WEAK BOND PANEL NO. 18

TEST PRESSURE 1100 PSI

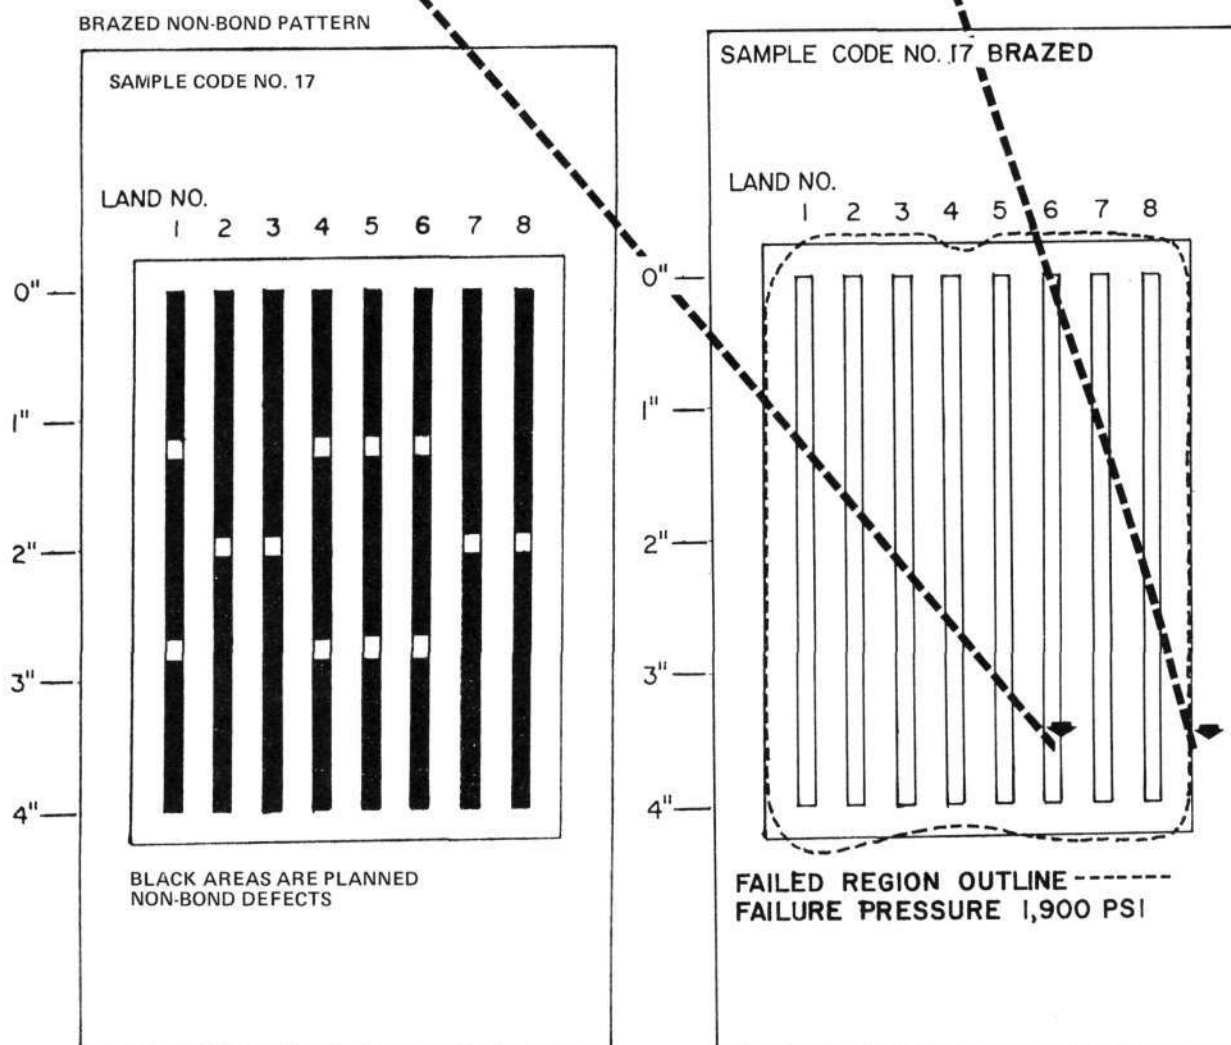
FIGURE A-26

TEST RESULTS ON BRAZED NON-BOND PANEL NO. 17

TEST PRESSURE 120 PSI

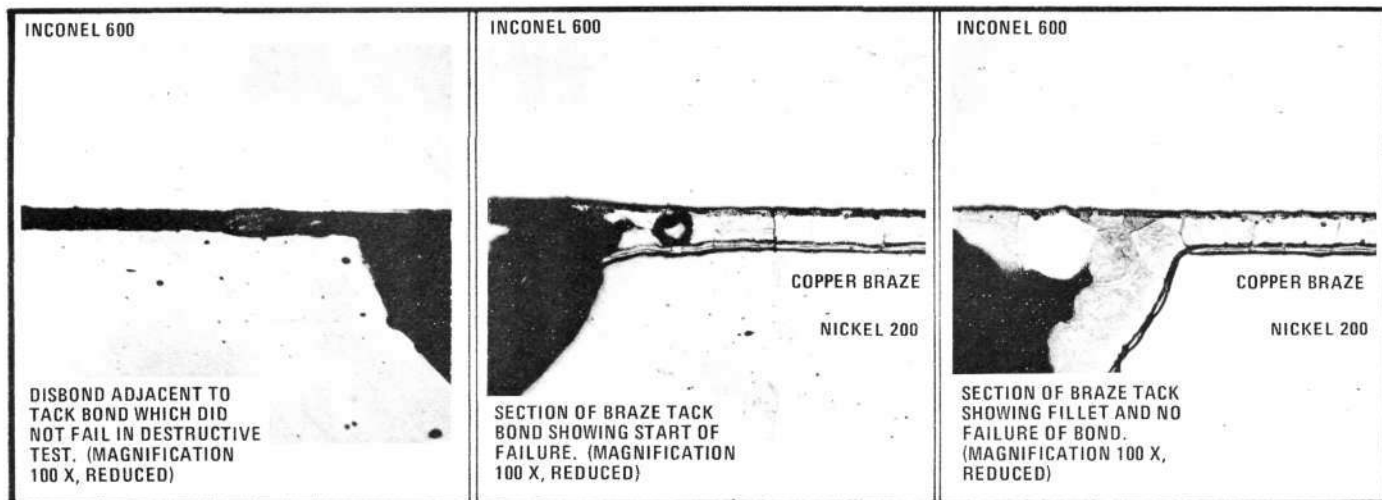
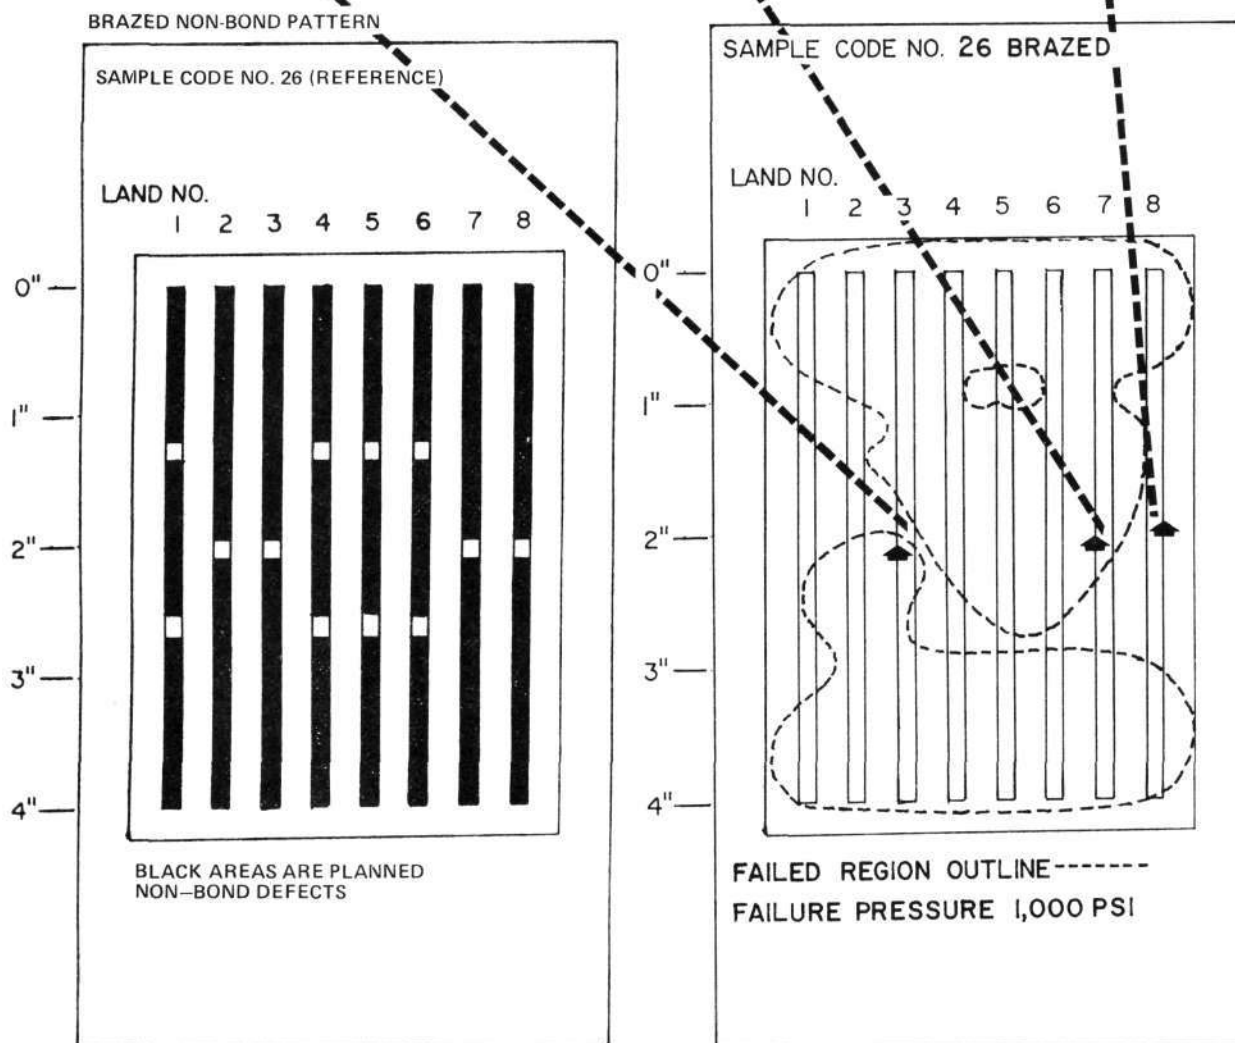
FIGURE A-27

TEST RESULTS FOR BRAZED NON-BOND PANEL NO. 26

TEST PRESSURE 100 PSI

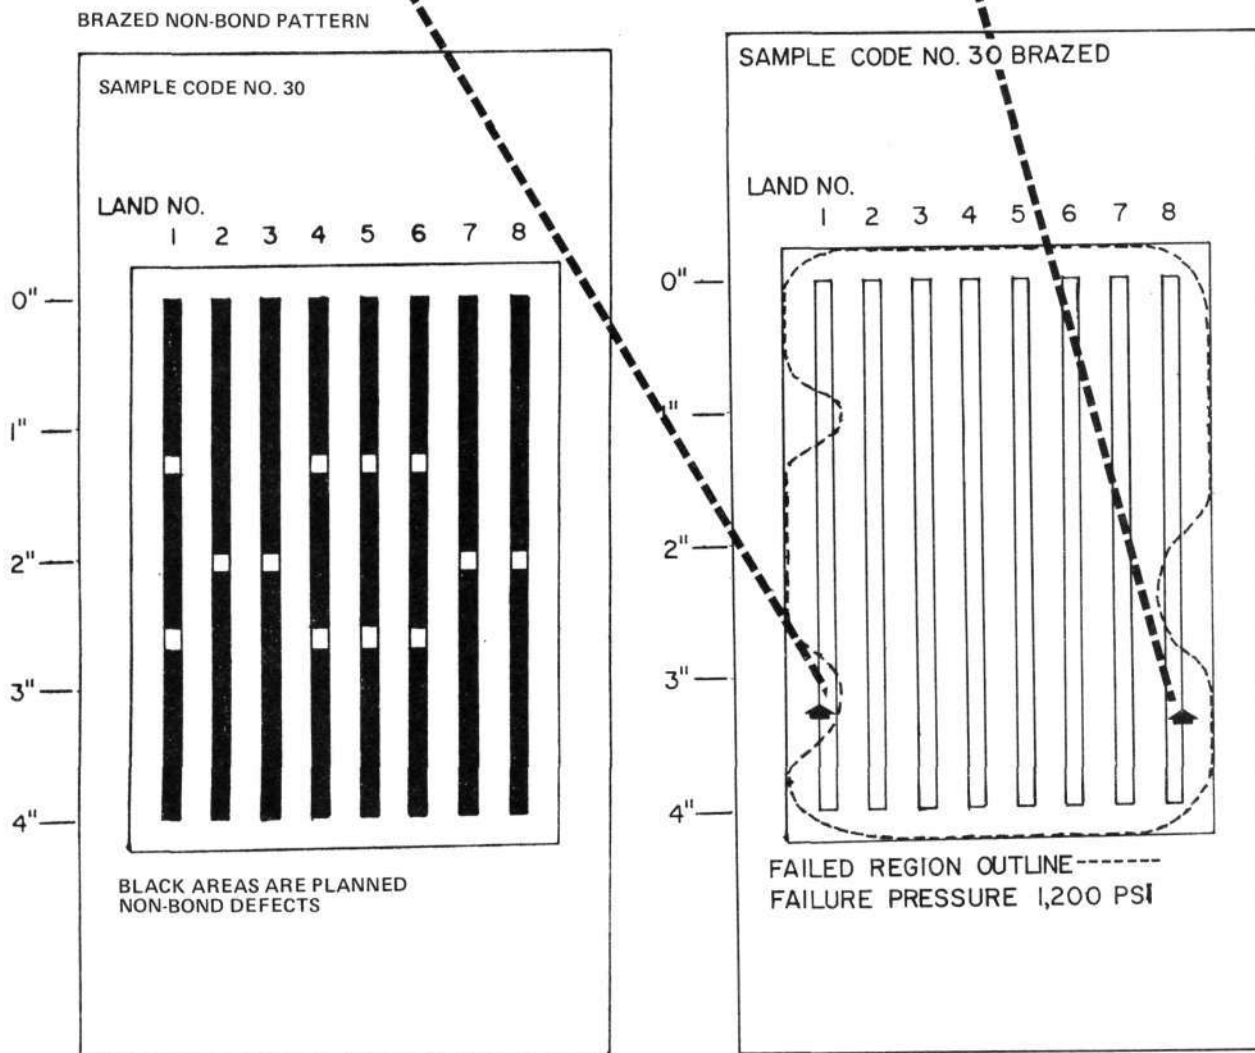
FIGURE A-28

TEST RESULTS ON BRAZED NON-BOND PANEL NO. 30

TEST PRESSURE 80 PSI

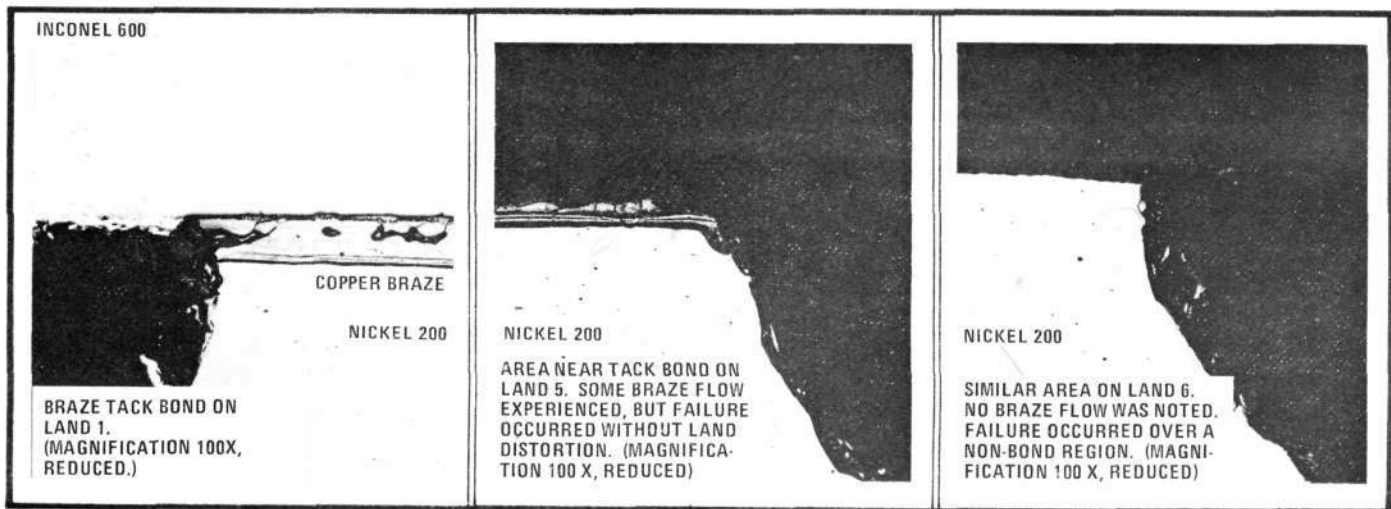
FIGURE A-29

# BRAZED NON-BOND PATTERN

TEST RESULTS ON BRAZED NON-BOND PANEL NO. 33

TEST PRESSURE 80 PSI

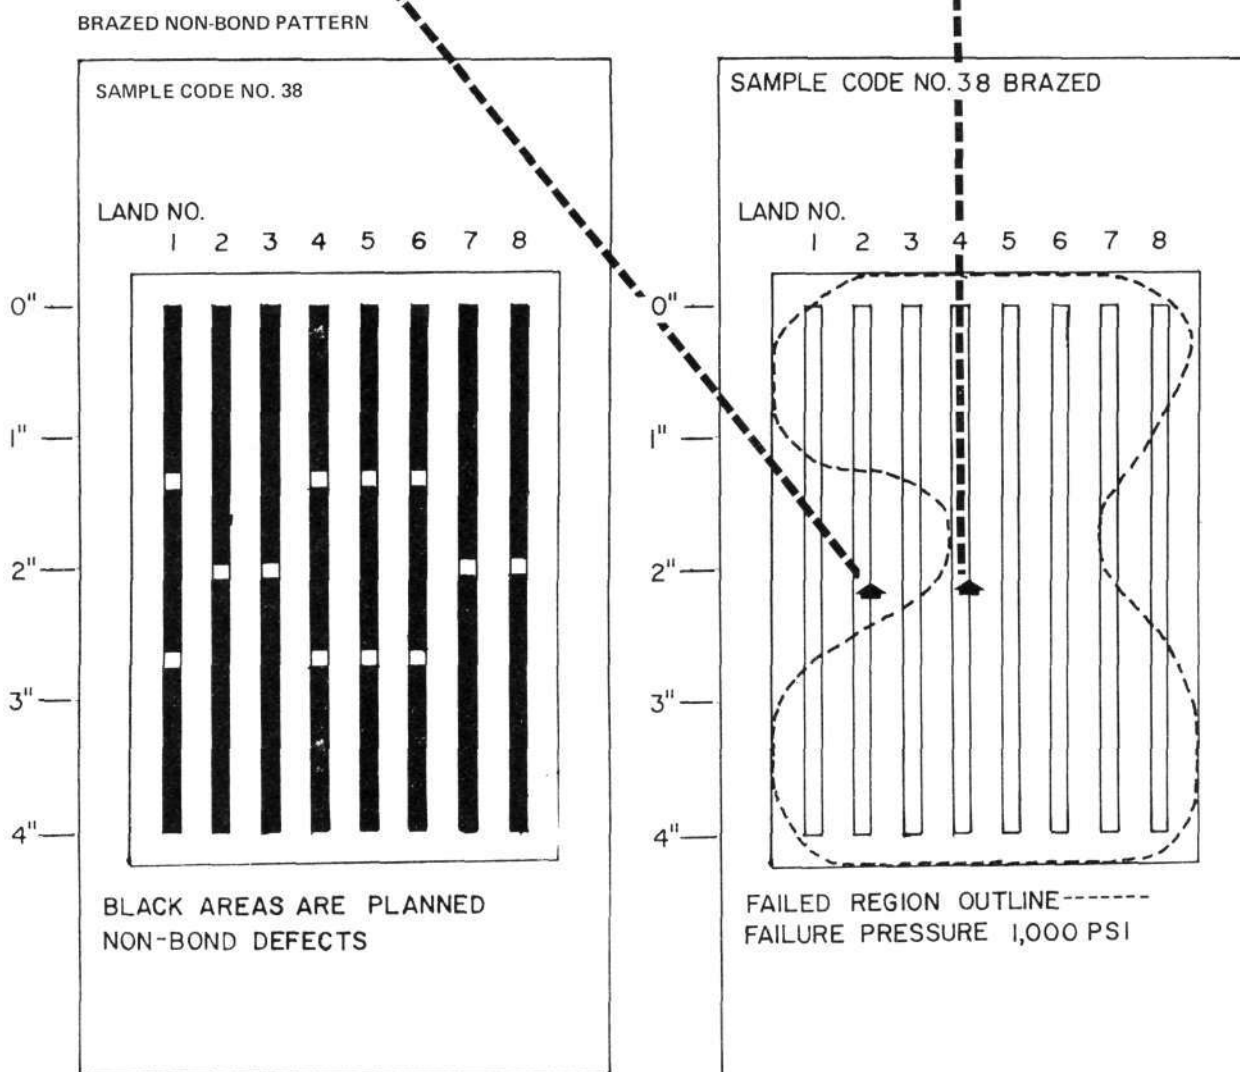
FIGURE A-30

TEST RESULTS ON BRAZED NON-BOND PANEL NO. 38

TEST PRESSURE 90 PSI

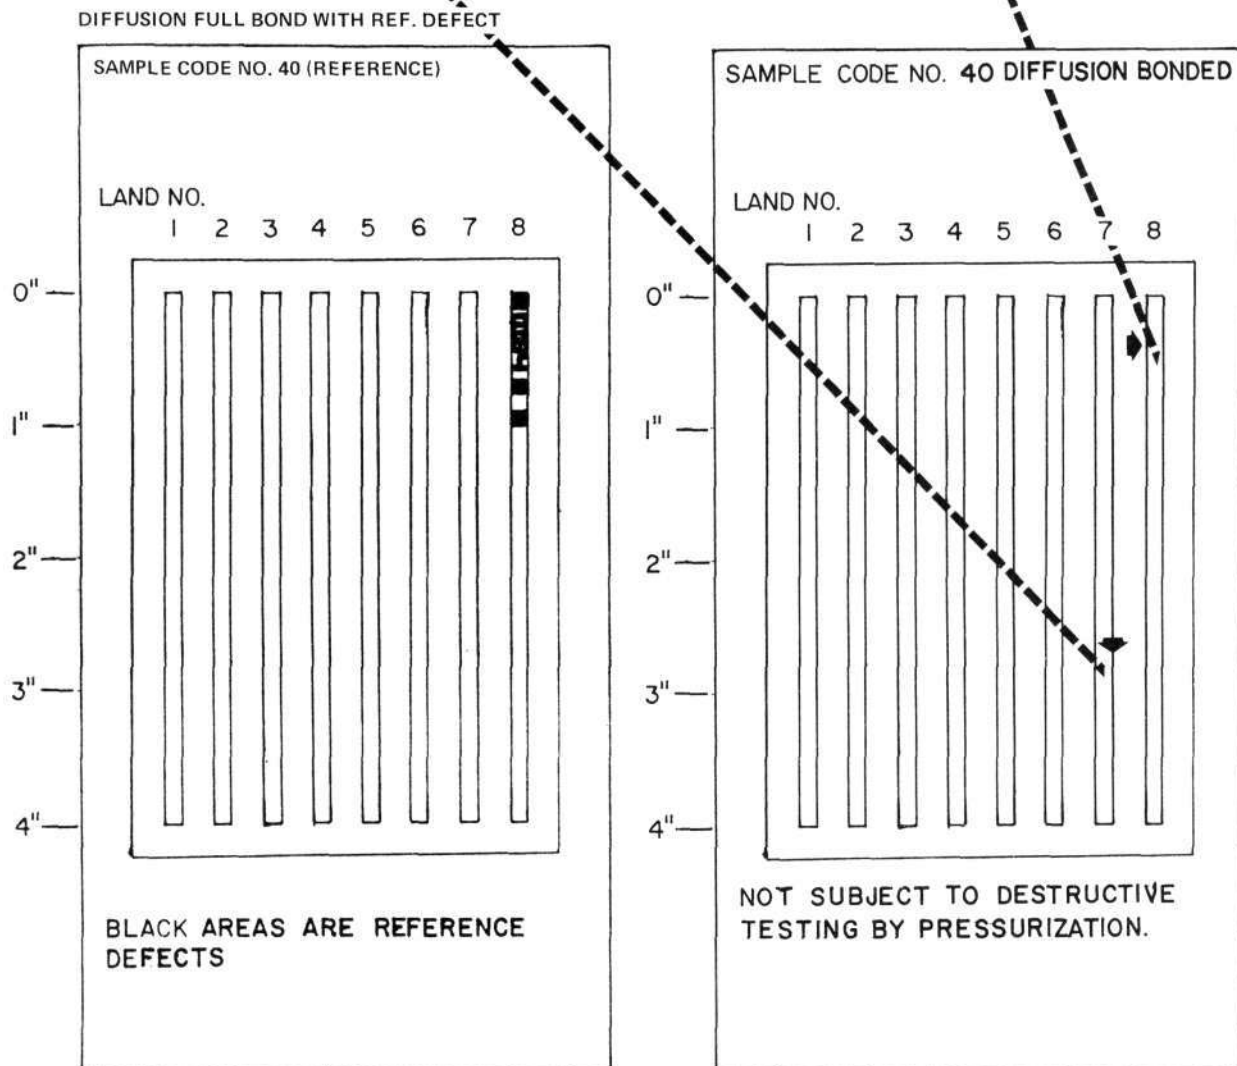
FIGURE A-31

TEST RESULTS ON DIFFUSION FULL BOND PANEL NO. 40

TEST PRESSURE - 1440 PSI

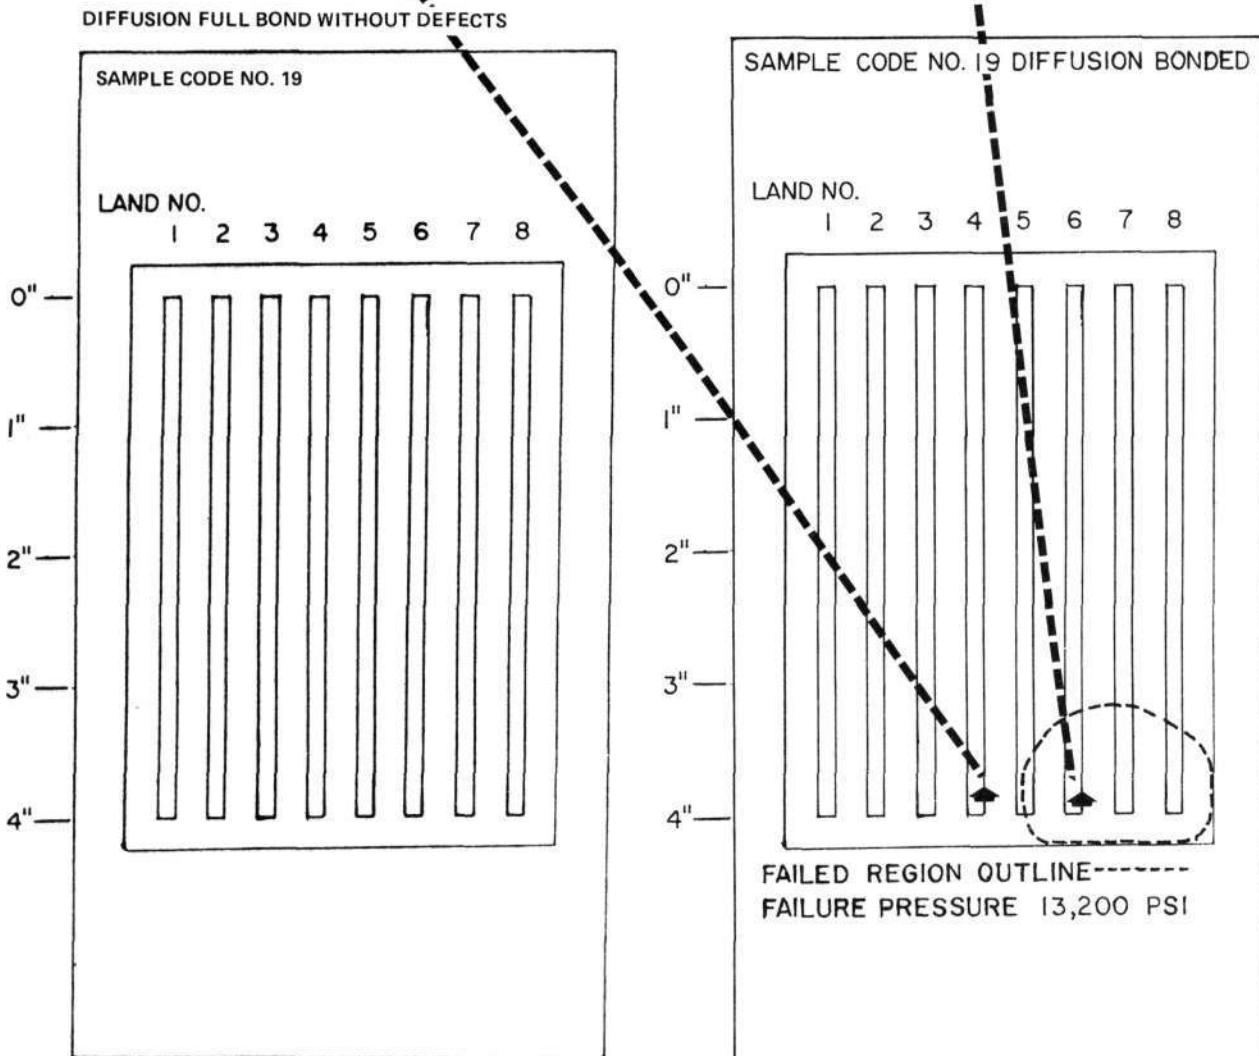
FIGURE A-32

TEST RESULTS ON DIFFUSION FULL BOND PANEL NO. 19

TEST PRESSURE 1450 PSI

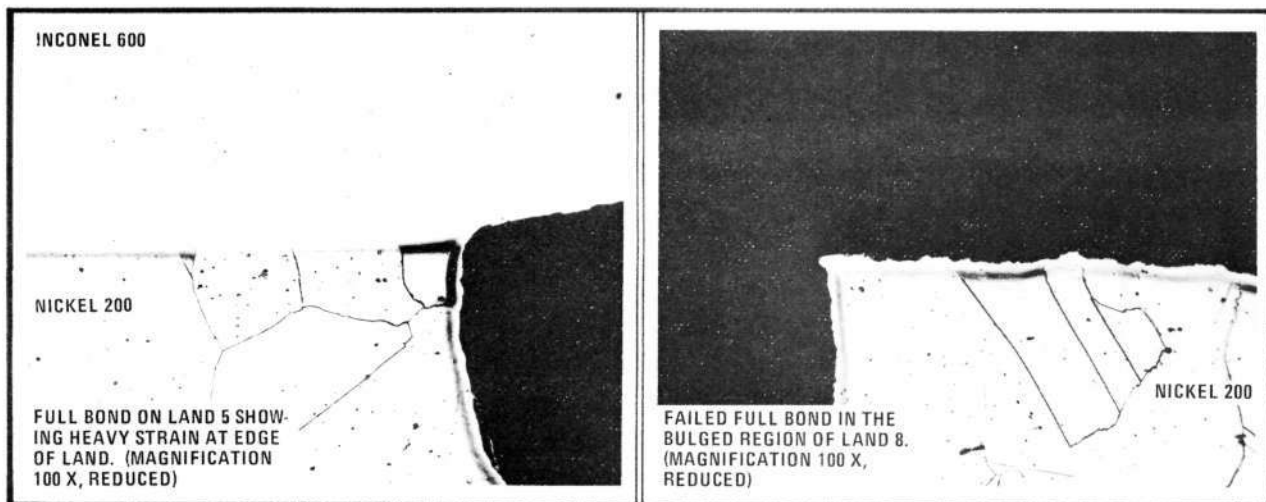
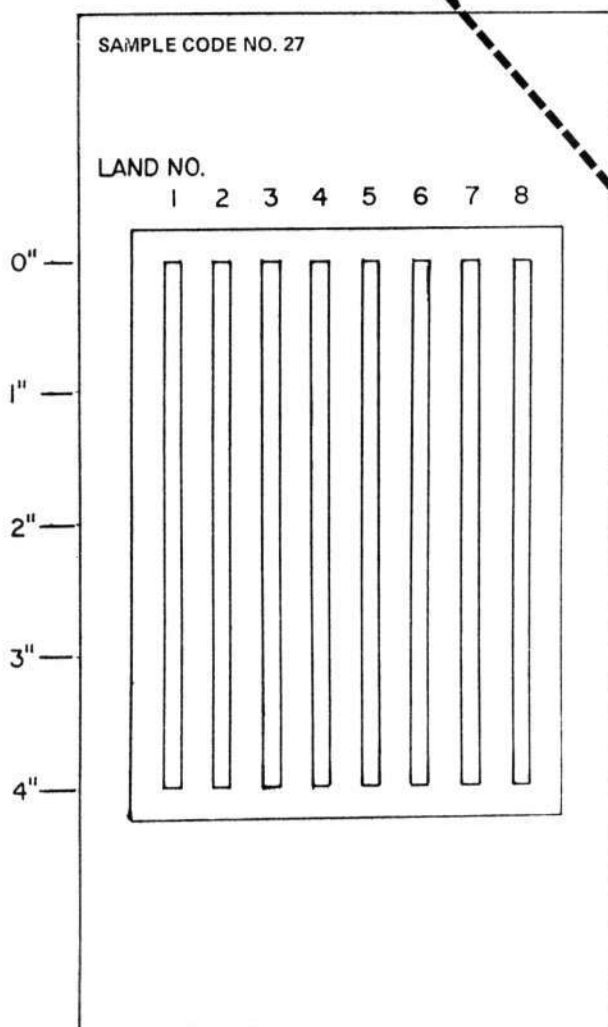
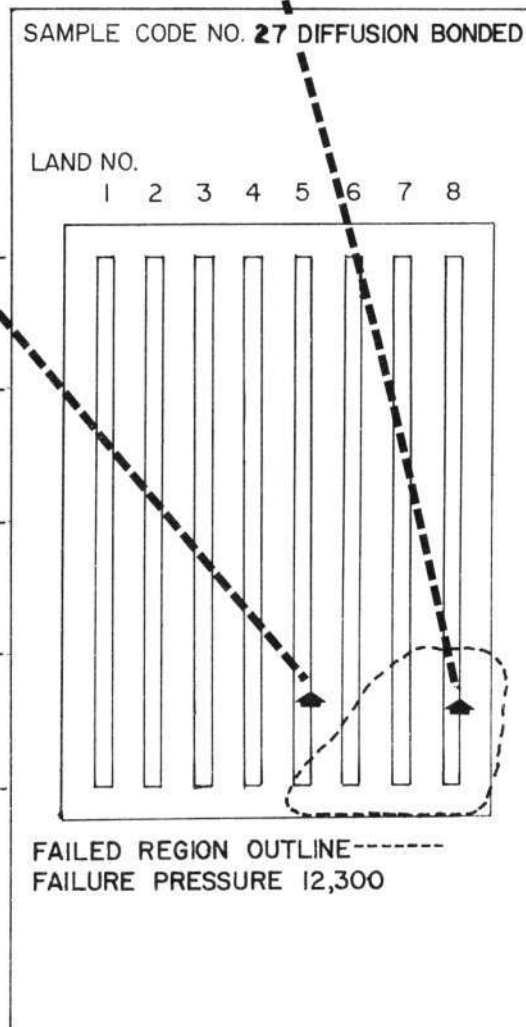
FIGURE A-33

# DIFFUSION FULL BOND WITHOUT DEFECTS

TEST RESULTS ON DIFFUSION FULL BOND PANEL NO. 27

TEST PRESSURE 1380 PSI

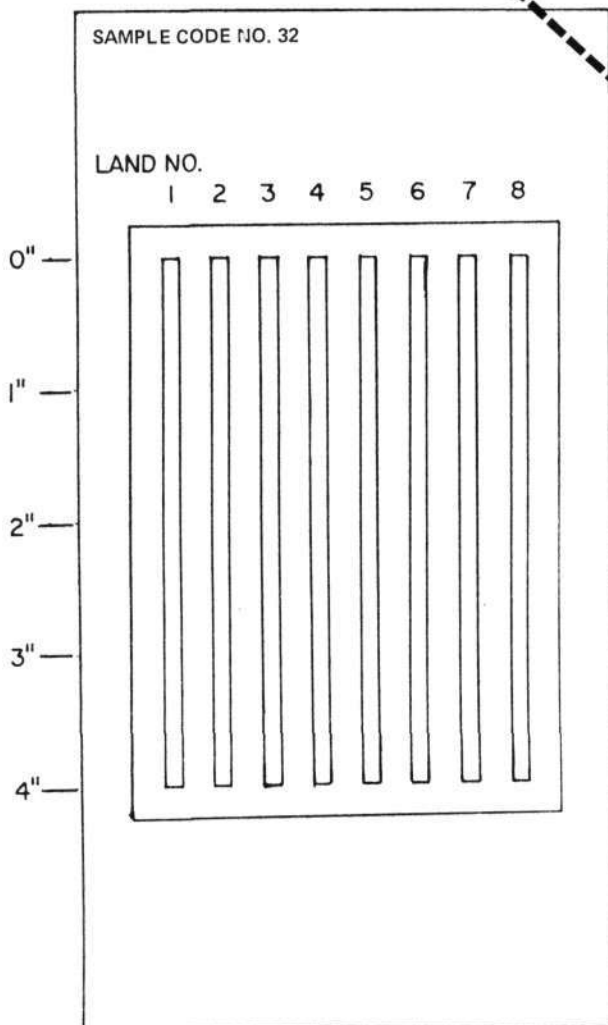
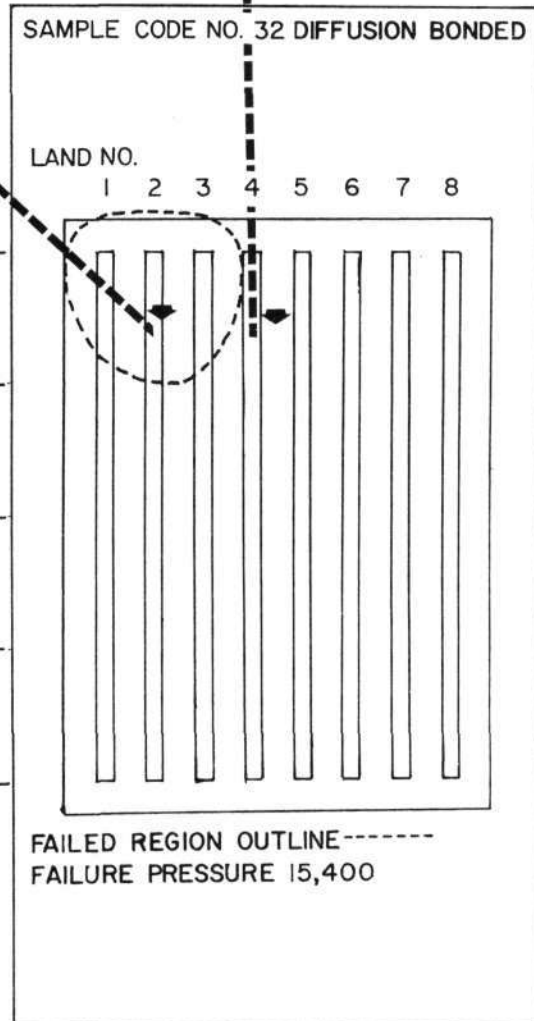
FIGURE A-34

DIFFUSION FULL BOND WITHOUT DEFECTS

TEST RESULTS ON DIFFUSION FULL BOND PANEL NO. 32

TEST PRESSURE 1440 PSI

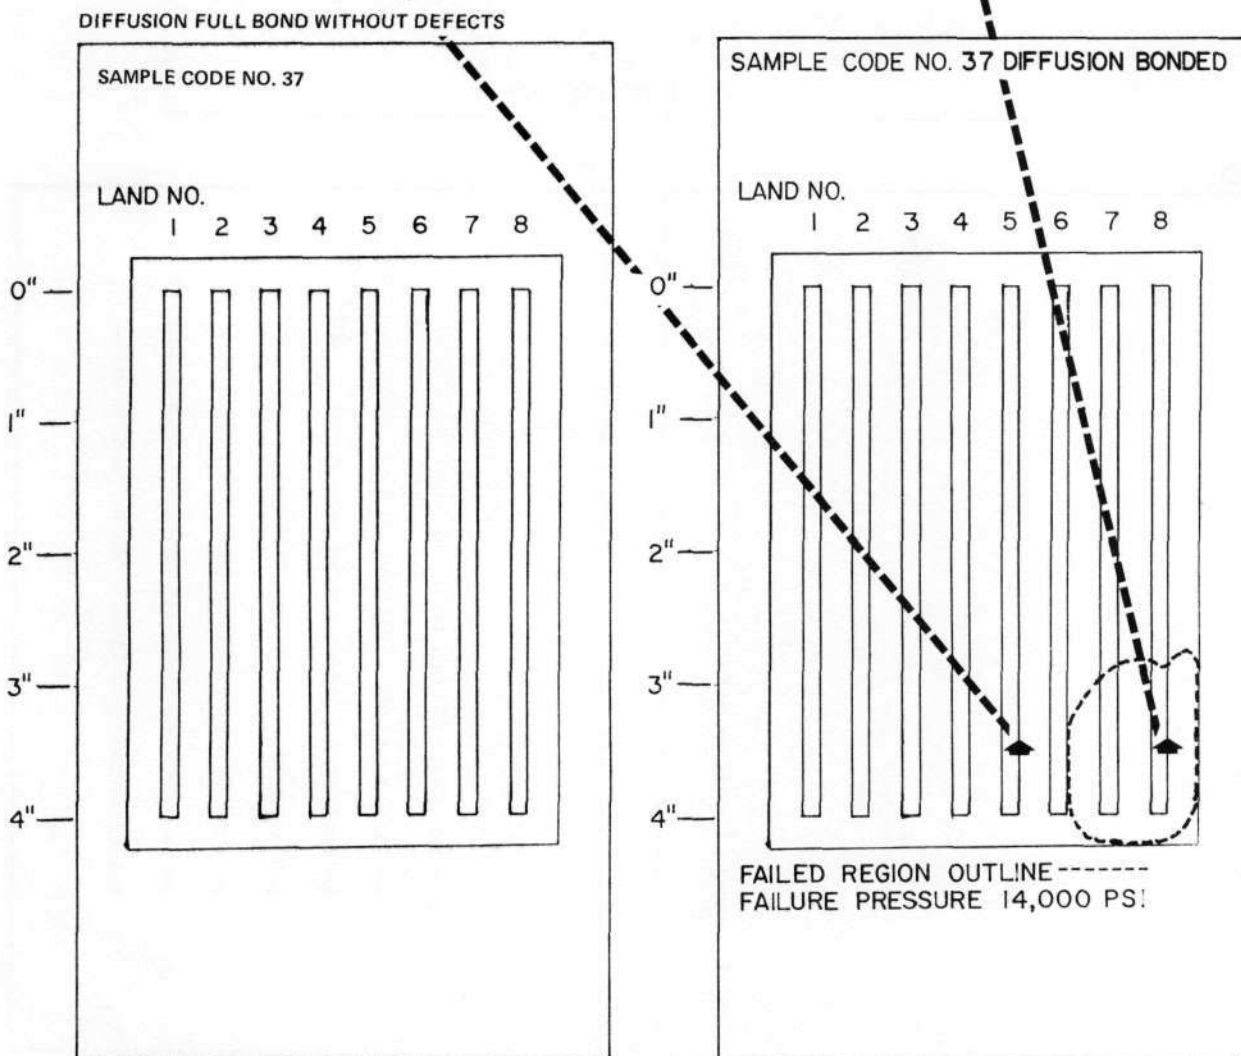
FIGURE A-35

TEST RESULTS ON DIFFUSION FULL BOND PANEL NO. 37

TEST PRESSURE 1380 PSI

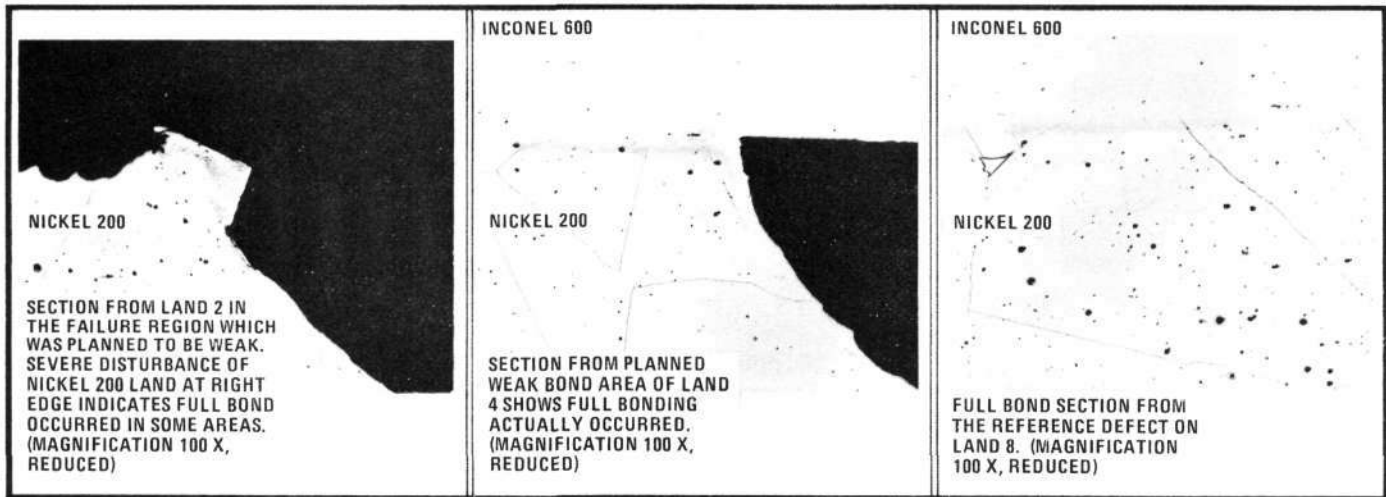
FIGURE A-36

DIFFUSION WEAK BOND—PATTERN 1

TEST RESULTS ON DIFFUSION WEAK BOND PANEL NO. 36

TEST PRESSURE - 500 PSI

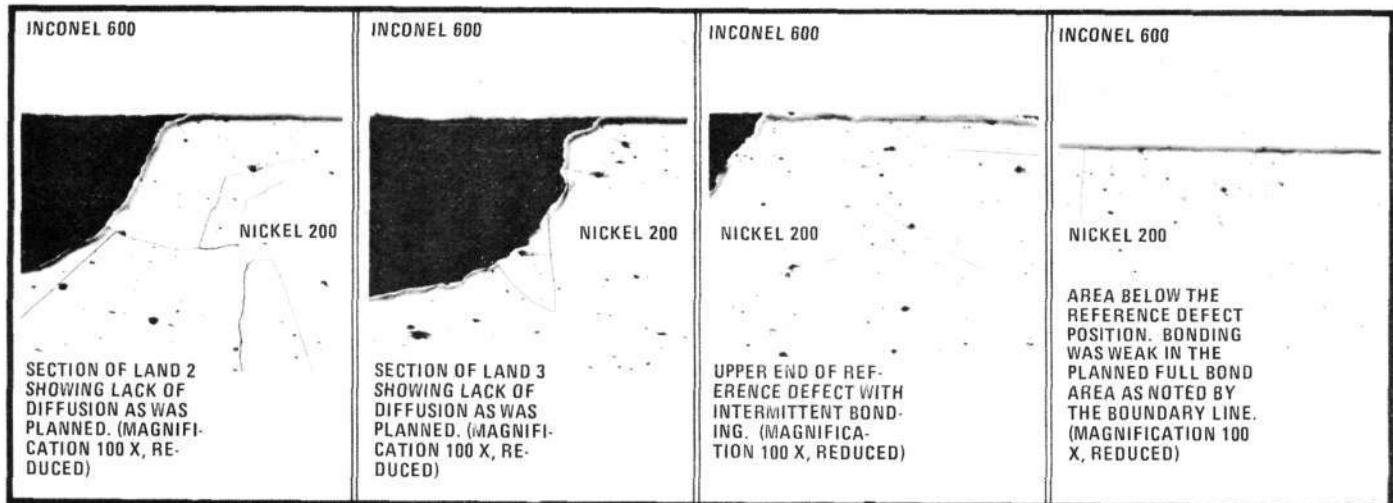
FIGURE A-37

TEST RESULTS ON DIFFUSION WEAK BOND PANEL NO. 48

TEST PRESSURE 1400 PSI

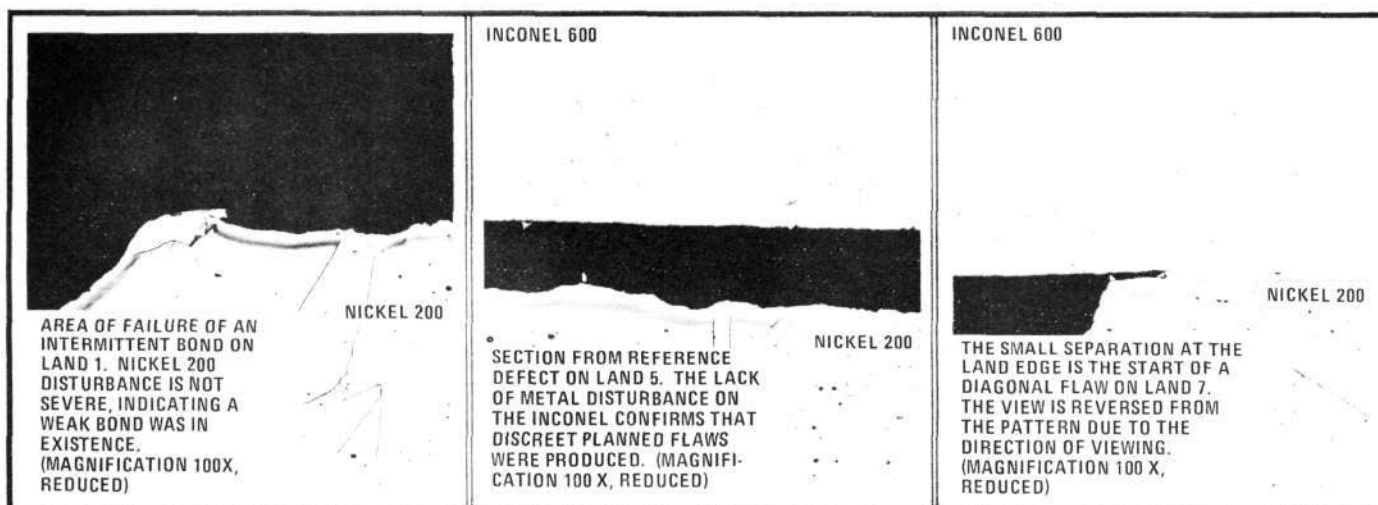
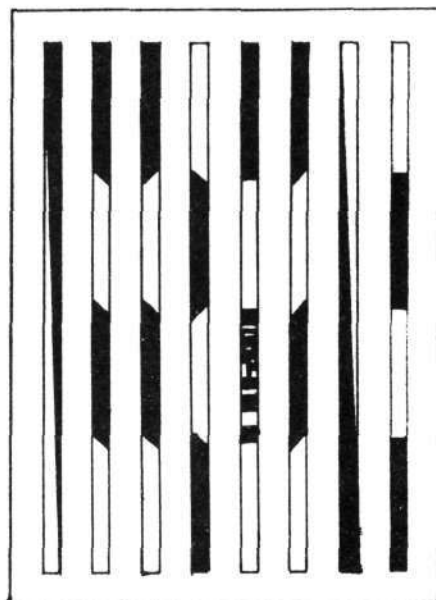
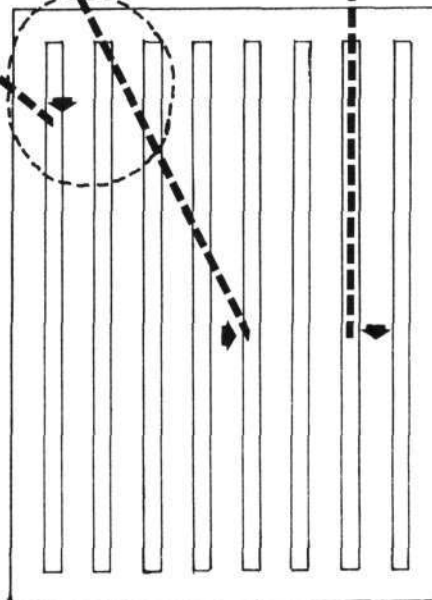
FIGURE A-39

# DIFFUSION WEAK BOND - PATTERN 3

BLACK AREAS ARE PLANNED DEFECTS  
LAND 5 CONTAINS A REFERENCE  
DEFECT

FAILED REGION OUTLINE-----  
FAILURE PRESSURE 8,800 PSI

TEST RESULTS ON DIFFUSION WEAK BOND PANEL NO. 29

TEST PRESSURE 1440 PSI

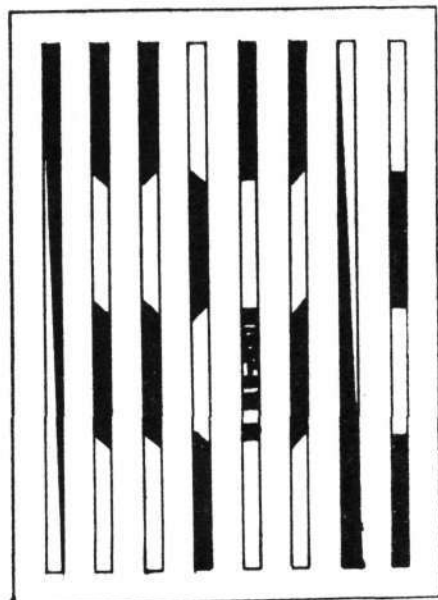
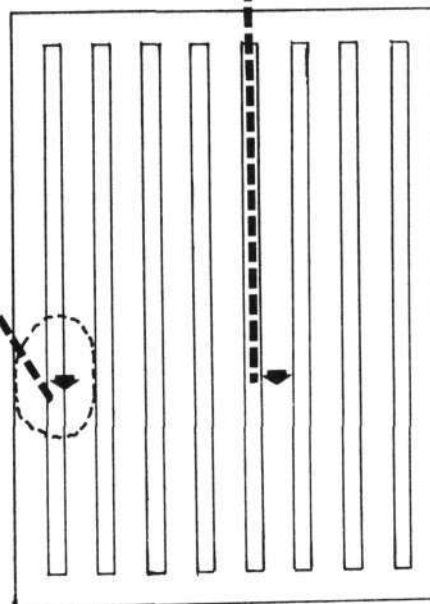
FIGURE A-40

# DIFFUSION WEAK BOND - PATTERN 3

BLACK AREAS ARE PLANNED DEFECTS  
LAND 5 CONTAINS A REFERENCE  
DEFECT

FAILED REGION OUTLINE-----  
FAILURE PRESSURE 8,000 PSI

TEST RESULTS ON DIFFUSION WEAK BOND PANEL NO. 43

TEST PRESSURE 1400 PSI

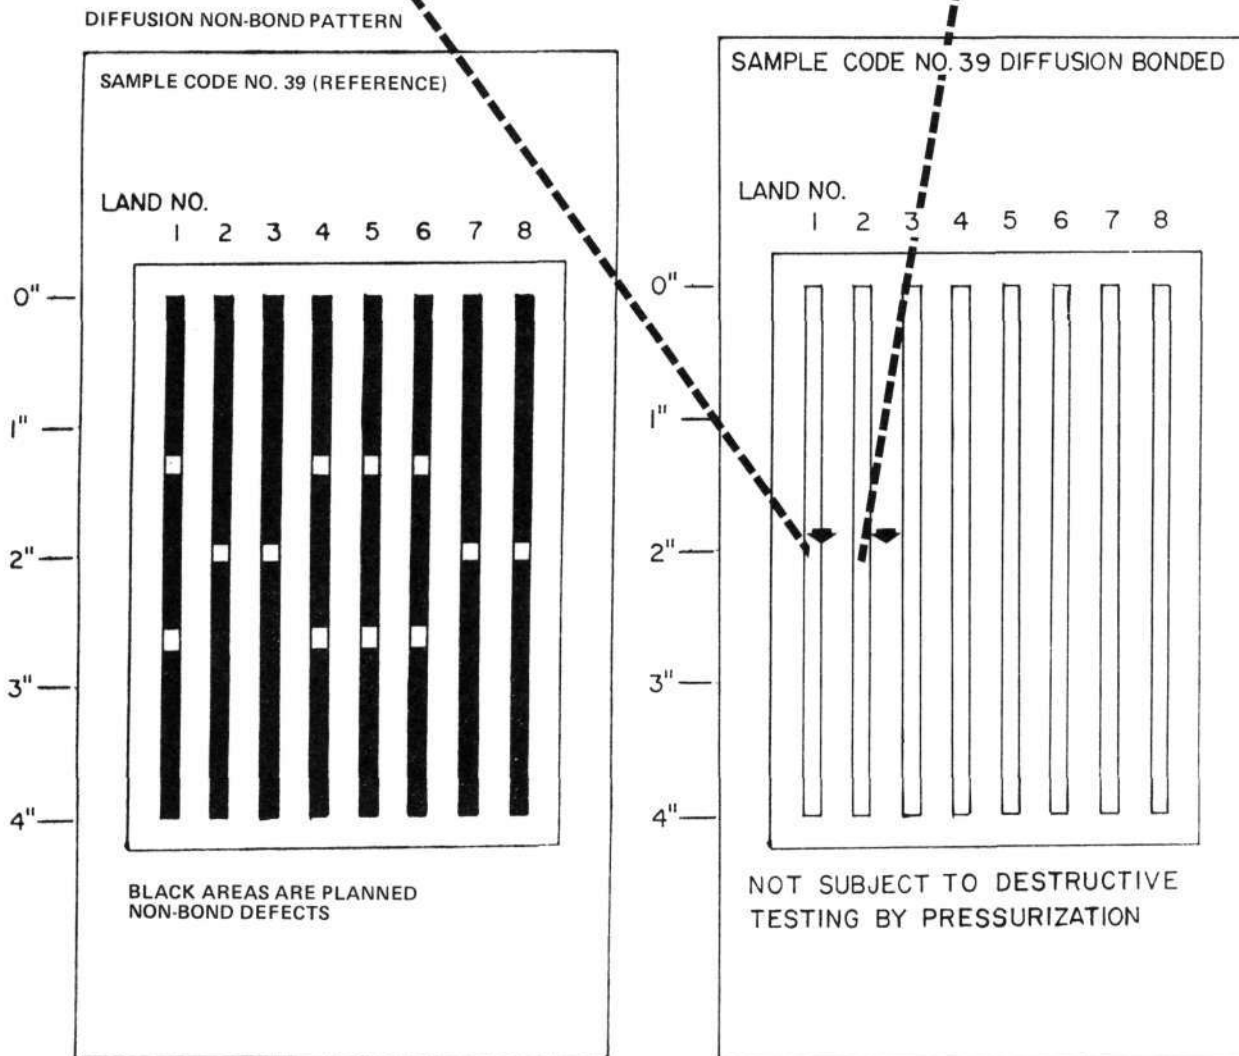
FIGURE A-41

TEST RESULTS ON DIFFUSION NON-BOND PANEL NO. 39

TEST PRESSURE 1380 PSI
